Inspection Report

Report Date 29/07/2009

Company Elite Home on Homes Inspection

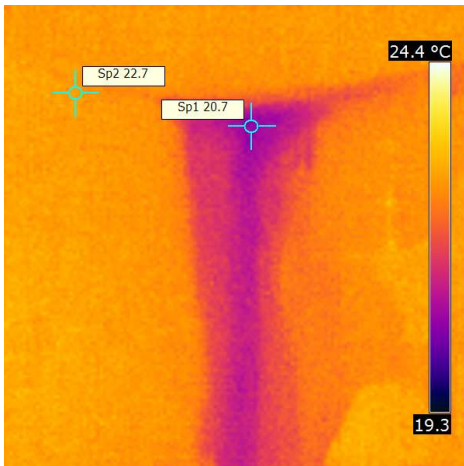
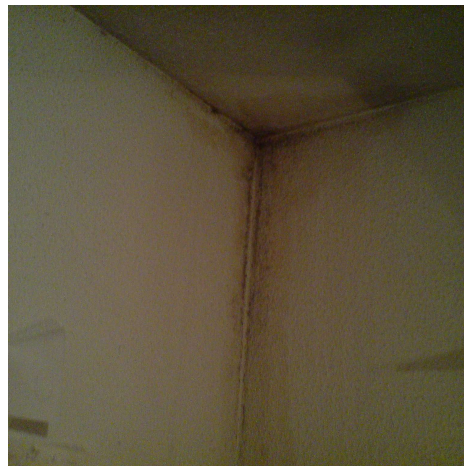
Dark area is water damage Mold Found!! Health Hazard

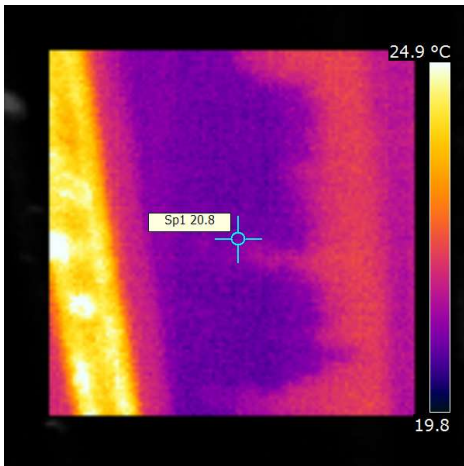
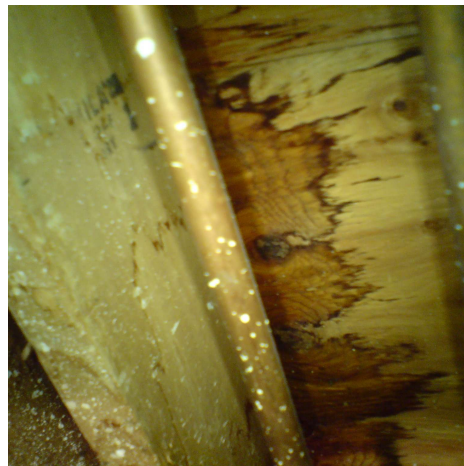
Water Damage!!

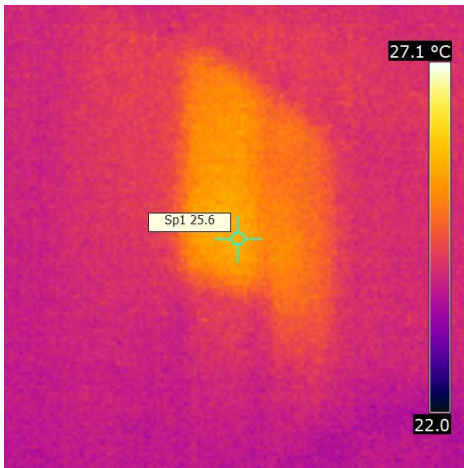
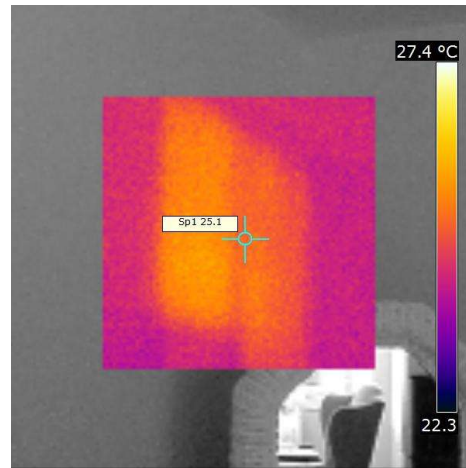
Missing Insulation (Bright Area)

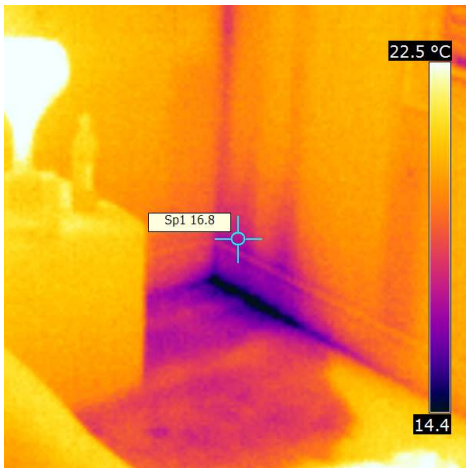
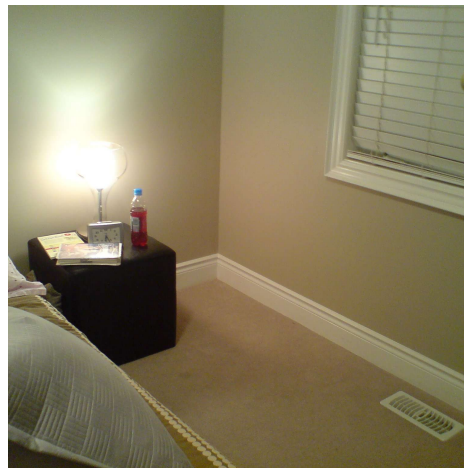
The area in the second floor bedroom is potentially the origin of the leak.

Can you find the water damage?

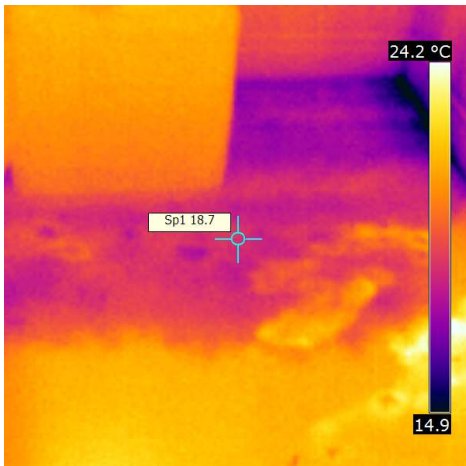
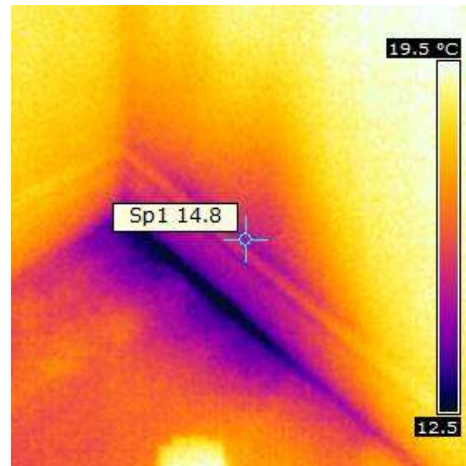
The carpet in the bedroom is saturated with water. Possible point of origin were leak is coming from.

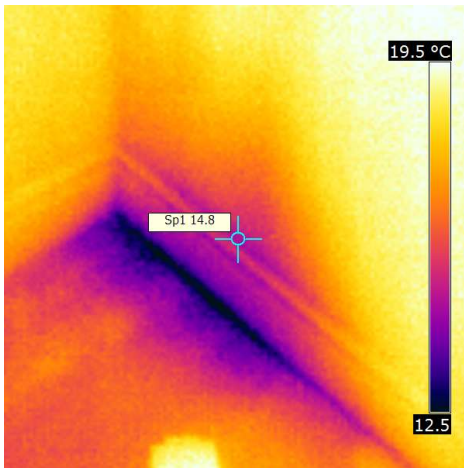
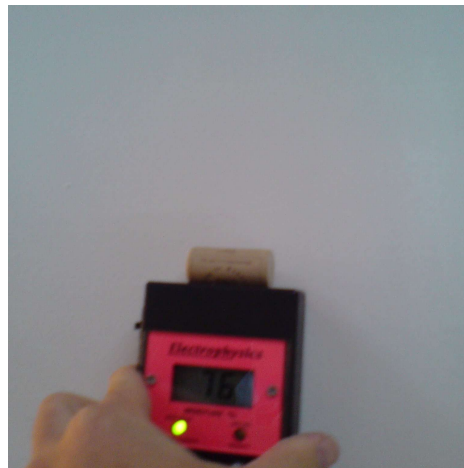
Possible point of origin were leak is coming from.

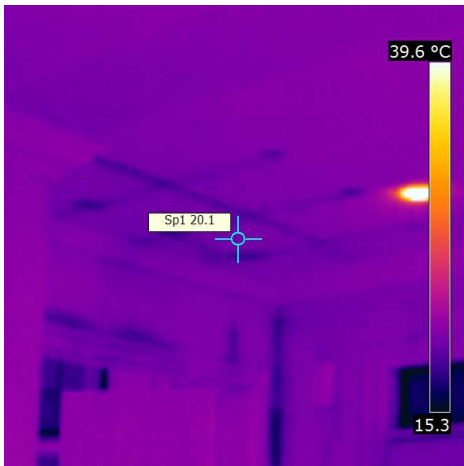
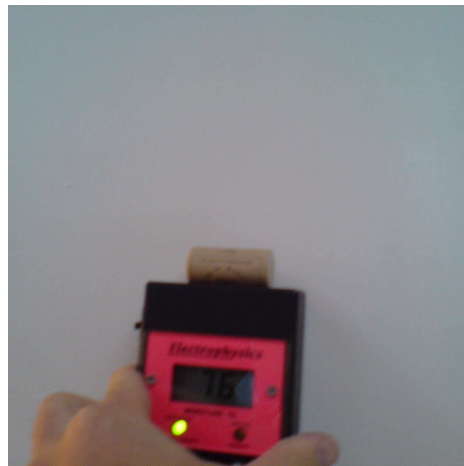
Water Damage to the exact location!! (Dark Areas)

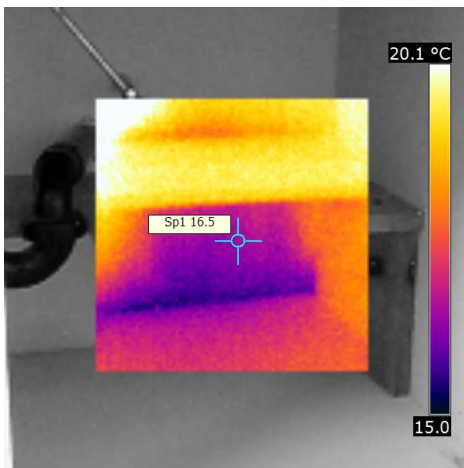
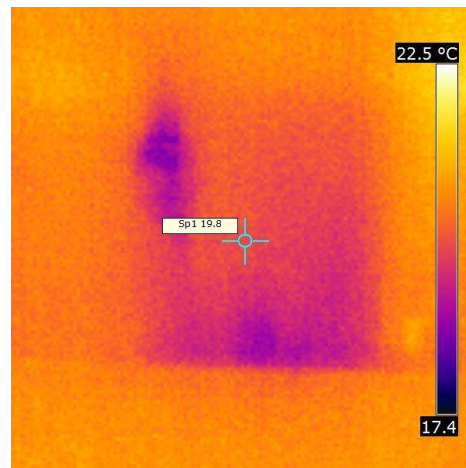
Water Damage found behind the wall!! Who would of thought?

Water Damage below the Drain pipe

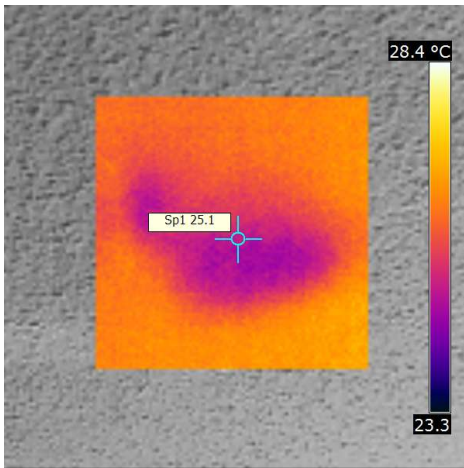
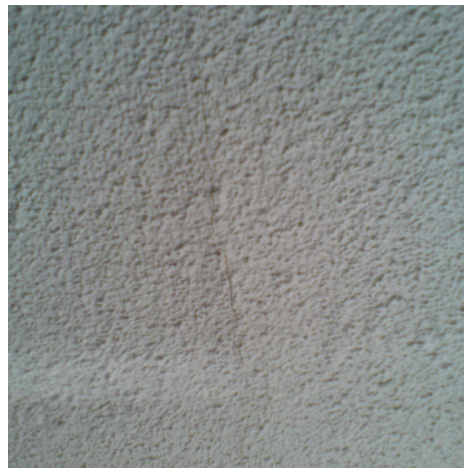
Well by the naked eye it appears to be an old dried up crack. With the Infrared Camera we found it was an active Leak!!!

This crack appears to be an old dried out crack in the ceiling right!!

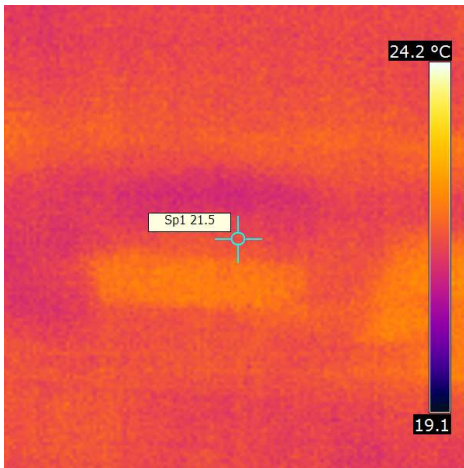
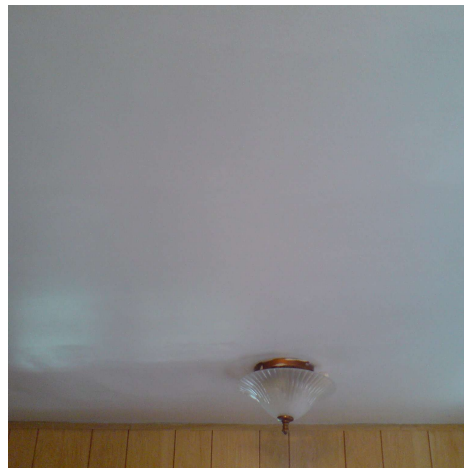
Again we located an active leak only through the Infrared Camera!!

Do you see the water leak????
